# Manhole Inspection Summary

Manhole # S47I\_\_050MH

Insp Date: **4/22/08 10:52 AM**

**Location** Address: **2234 eastern ave** Cross Street: **s patterson park**

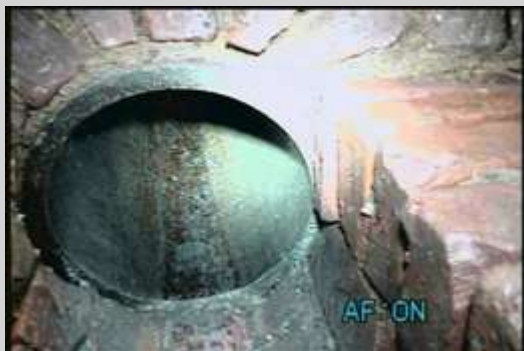
3 O'Clock Inflow

8 in. Circular Gravity Sewer  
Pipe In @ 3 OClock

Drop In @ 3 OClock

Pipe Height: **0** (in.) Direct  
Pipe Material: **Clay** ☐ Pipe Lined  
Invert Depth: **8.95** (ft.) Flow Characteristics: **Fast**  
Deposits: ☒ **None** ☐ Mud ☐ Sludge ☐ Debris ☐ Grease  
Silt Depth: **0** (in.) Deposits Extent:  
Infiltration: **None** Pipe Seal Cond: **Unknown**

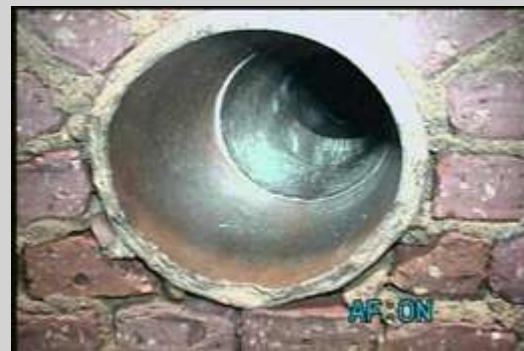
Drop: **Outside Direct**  
Angled: Reading: **0.00** (ft.)  
Inv Depth: **9.25** (ft.)

Drop Condition: **Open**

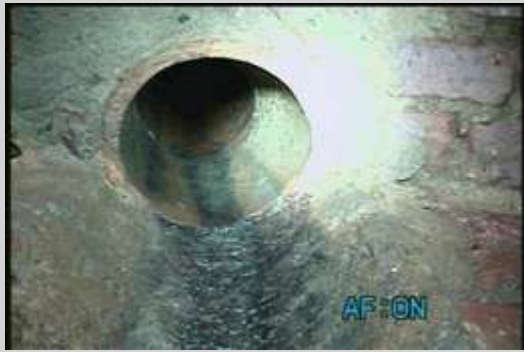
6 O'Clock Inflow

8 in. Circular Gravity Sewer

Pipe In @ 6 O'Clock

Invert Depth: **9.41** (ft.) Flow Characteristics: **Fast**

Deposits: ☒ None ☐ Mud ☐ Sludge ☐ Debris ☐ Grease

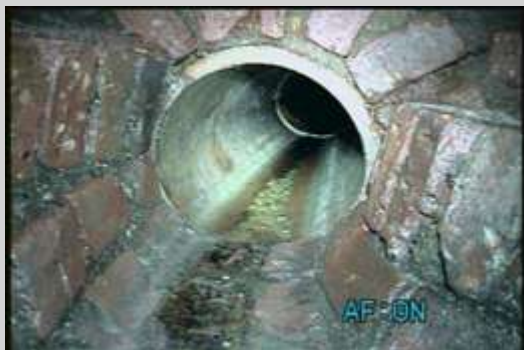
9 O'Clock Inflow

8 in. Circular Gravity Sewer

Pipe In @ 9 O'Clock

Infiltration: **None**
